Experimental Study ND 98-02

**Snow Management by the Use of
Snow Fence Systems**

First Evaluation

March 2003

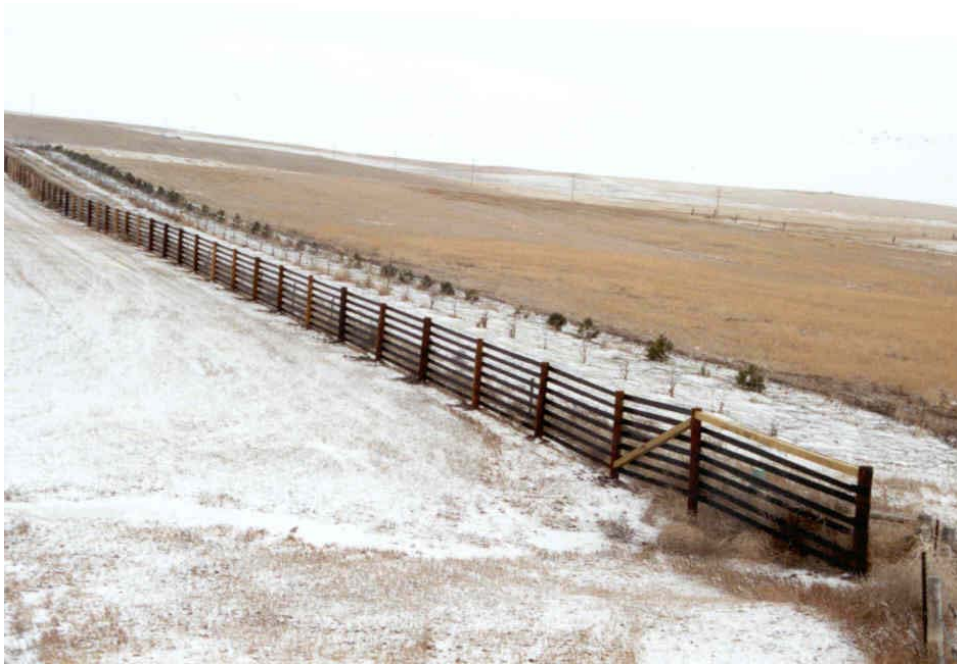
North Dakota Department of Transportation (NDDOT) has installed demonstration structural snow fence systems at four sites located on the interstate system. These four sites were problem areas due to poor visibility and snow accumulation on the roadway. One of the sites has an existing living snow fence, consisting of a young shelterbelt of Ash and Pine trees. Photo 1 shows a six feet tall structural snow fence with the living snow fence in February 1998.

Photo 1 - Structural snow fence and living snow fence in February 1998.

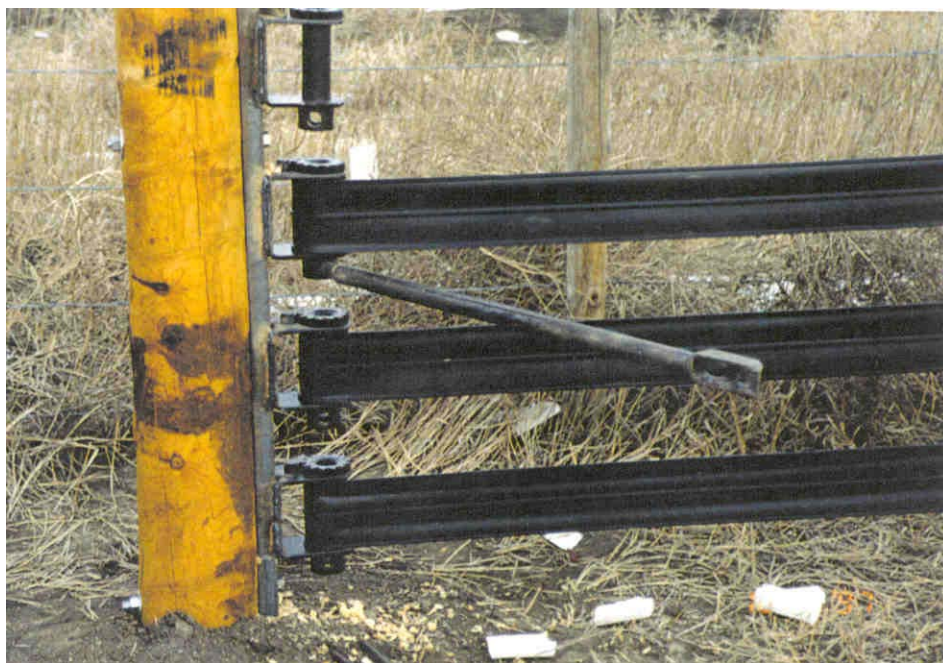
The structural snow fences were constructed with a post and rail design. The rail is a composite polymer strap in which three 10.5-gauge wires are embedded. This product, marketed as Centaur HTP fencing, is five inches wide and comes in lengths up to 660 feet. Because 40% to 50% fence porosity is considered ideal, the straps are spaced five inches apart. The straps are mounted to the posts by brackets that allow the straps to freely slide along the length of the strap and the straps are tensioned with a ratchet system permanently attached to a post on one end of the fence. Photo 2 shows the polymer straps being tensioned with the ratchet system during construction.

Photo 2 - Polymer straps are tensioned with a ratchet system.
